# PLANNING REPORT & STATEMENT OF ENVIRONMENTAL EFFECTS

Proposed intensive livestock agriculture facility (sheep feedlot)

'Culverley Rise', 198 Humphreys Road, Bungowannah

July 2020

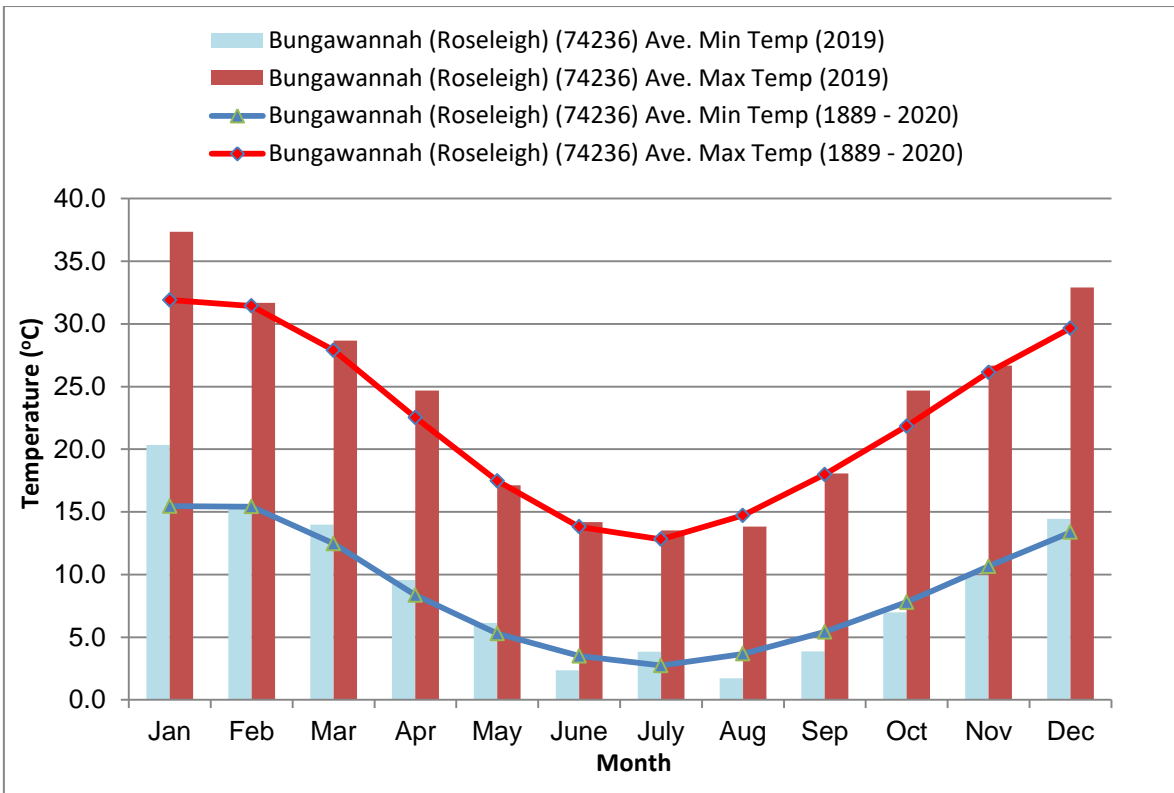
Figure 6 Average monthly temperatures (SILO data, 2020)
